TECHNICAL REPORT NO. 3-726

MOBILITY ENVIRONMENTAL RESEARCH STUDY  
A QUANTITATIVE METHOD FOR DESCRIBING  
TERRAIN FOR GROUND MOBILITY

SELECTED AIR-PHOTO PATTERNS OF TERRAIN FEATURES

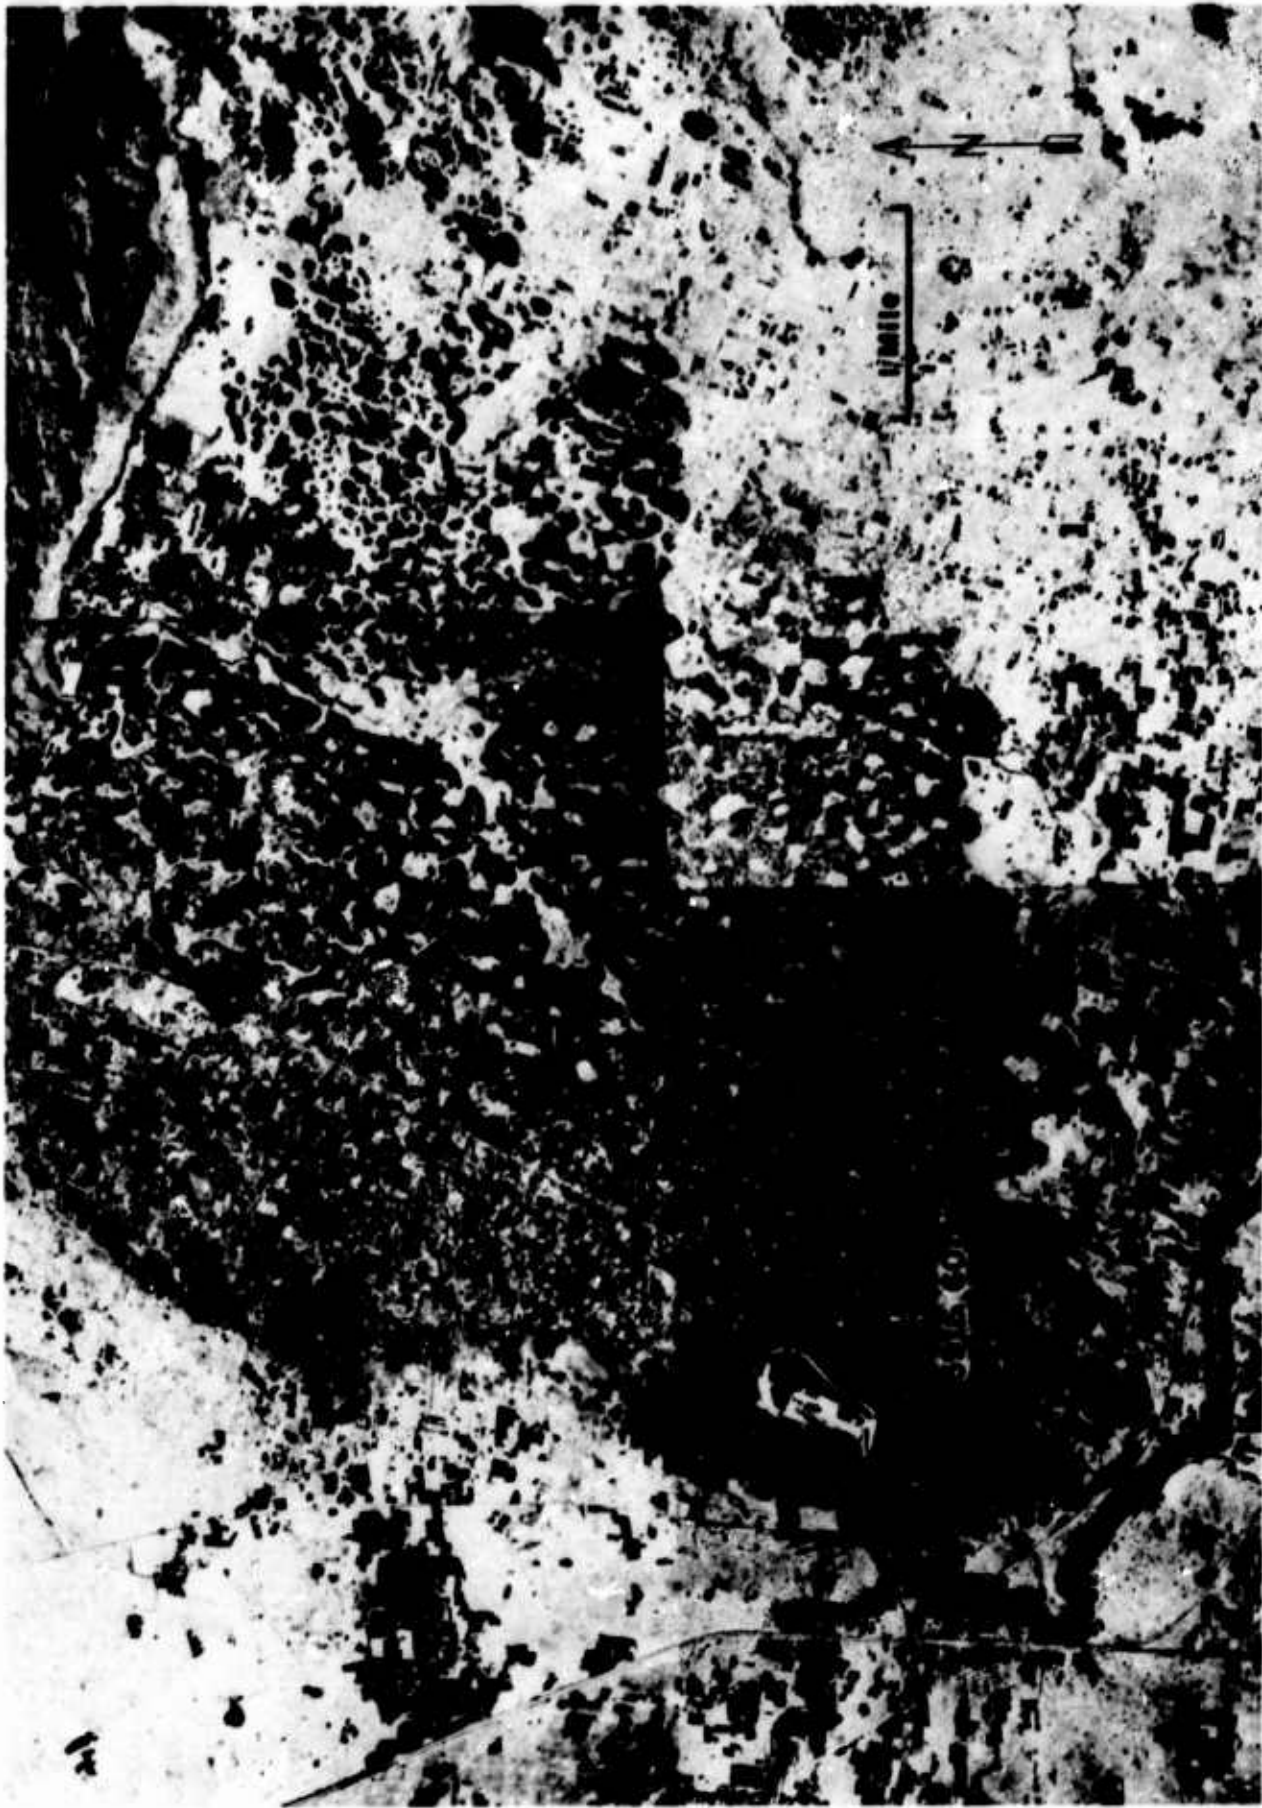
Fig. 21. Lop Buri clay--dark karst area of Lop Buri residual and sinkhole colluvial clays about 15 miles southeast of Lop Buri. Light-toned soils around perimeter of karst area are Lop Buri alluvial apron clays (February 1953)

- a. Appearance. Fig. 21 is an air-photo mosaic of a karst area located about 15 miles southeast of Lop Buri. A stereopair of a portion of this mosaic is shown in fig. 22. Twelve years later, and at a larger photo scale, this area appeared as shown in fig. 23. The karst patterns are characterized by (1) generally level ridges of relatively uniform height but random width and orientation, (2) flat-bottomed depressions or sinkholes of variable areal extent which may or may not have connecting channels, (3) trees, dry crops and brush occurring only on the ridges, and rice cultivation found only in the sinkholes, and (4) uniform photo tones on the ridges and diverse tones in the sinkholes.

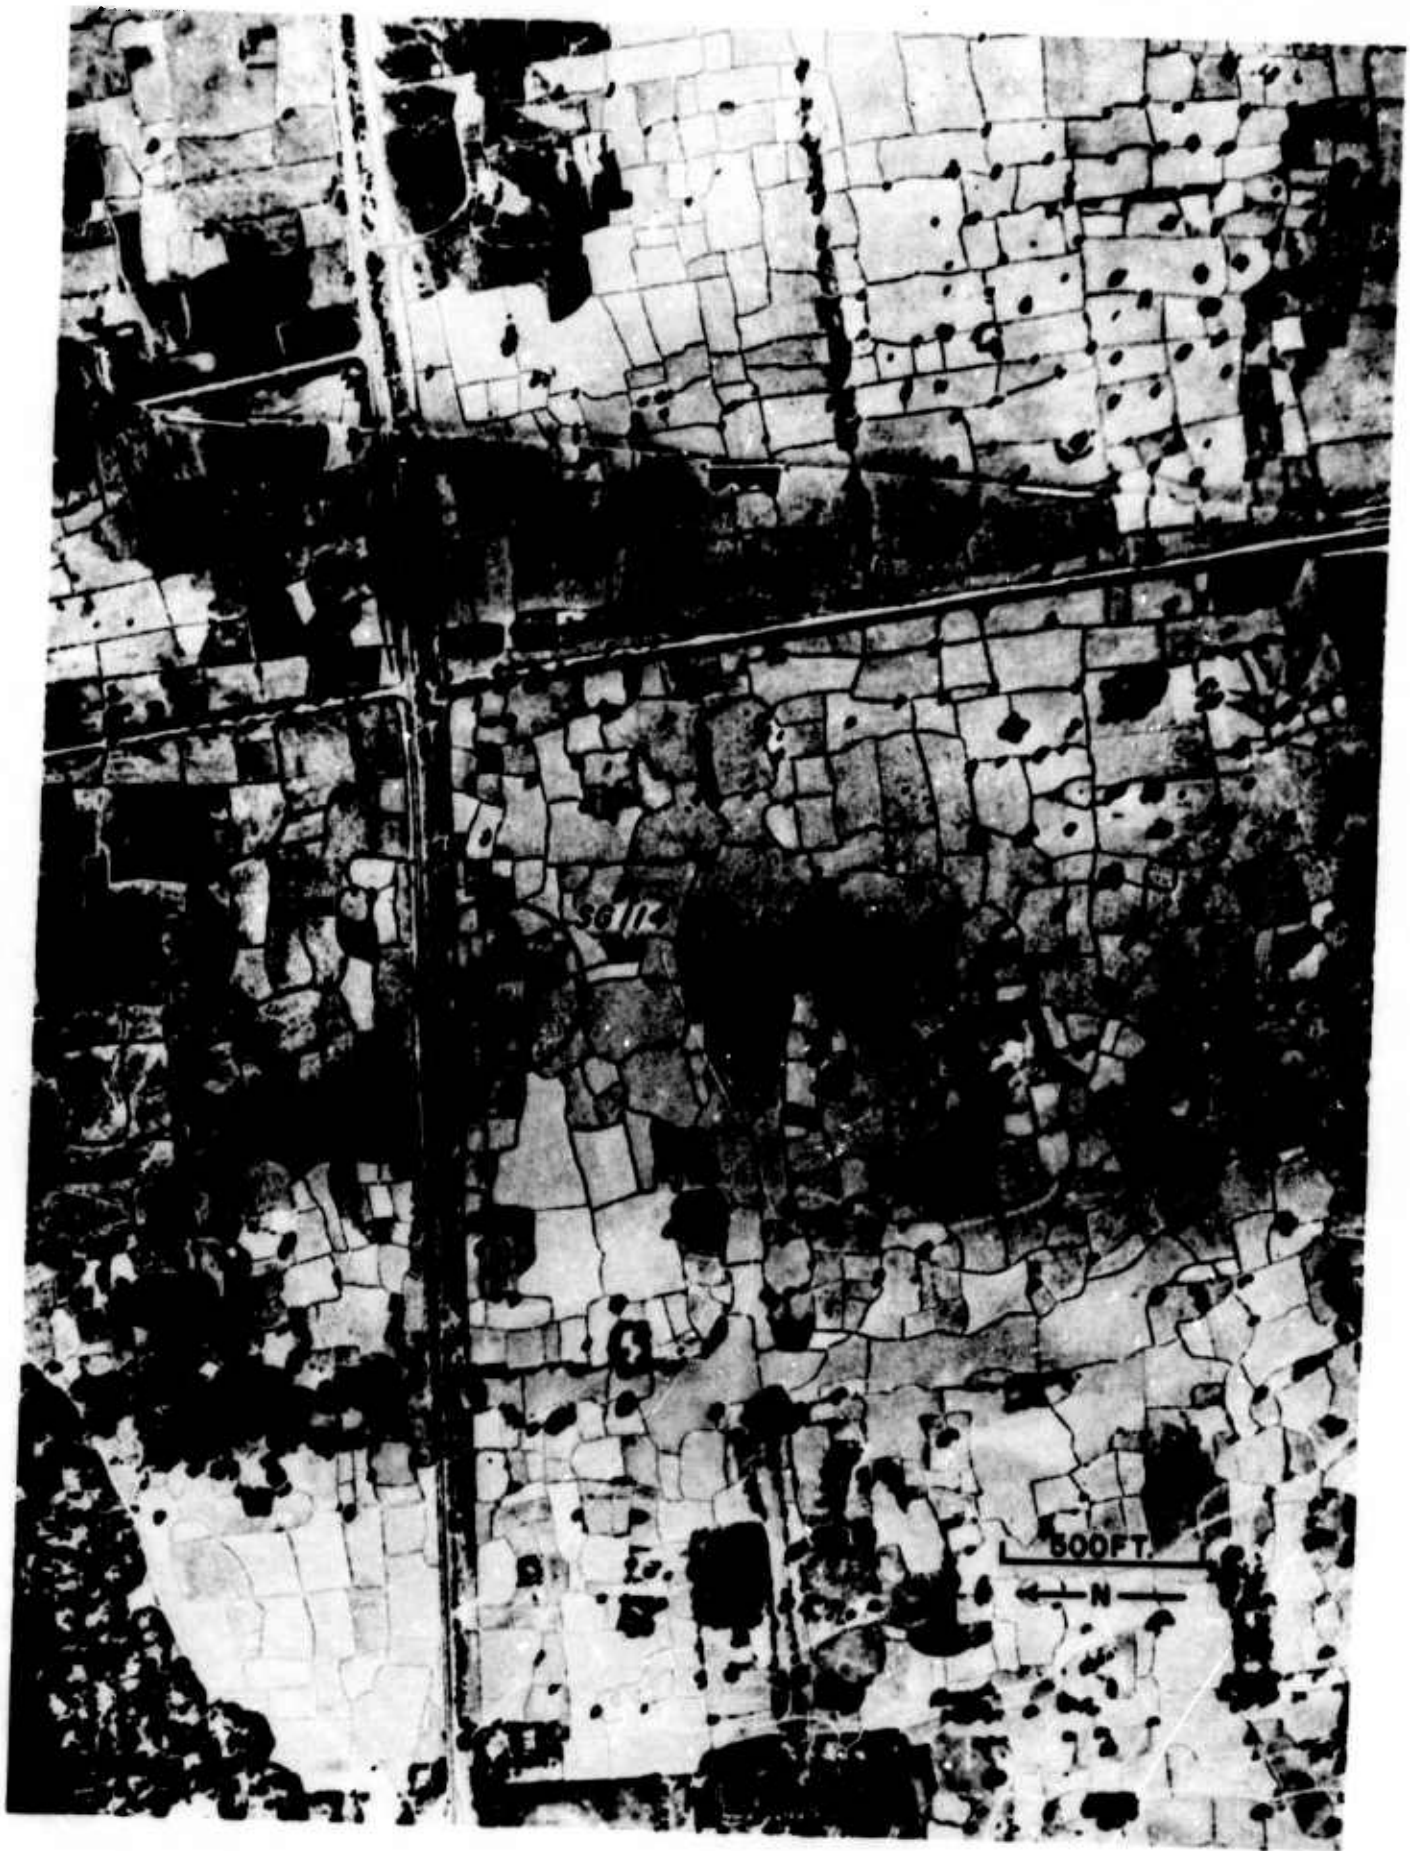
Fig. 83. Terraced paddies--dike plan view and cross sections at site SG-116 (September 1964)

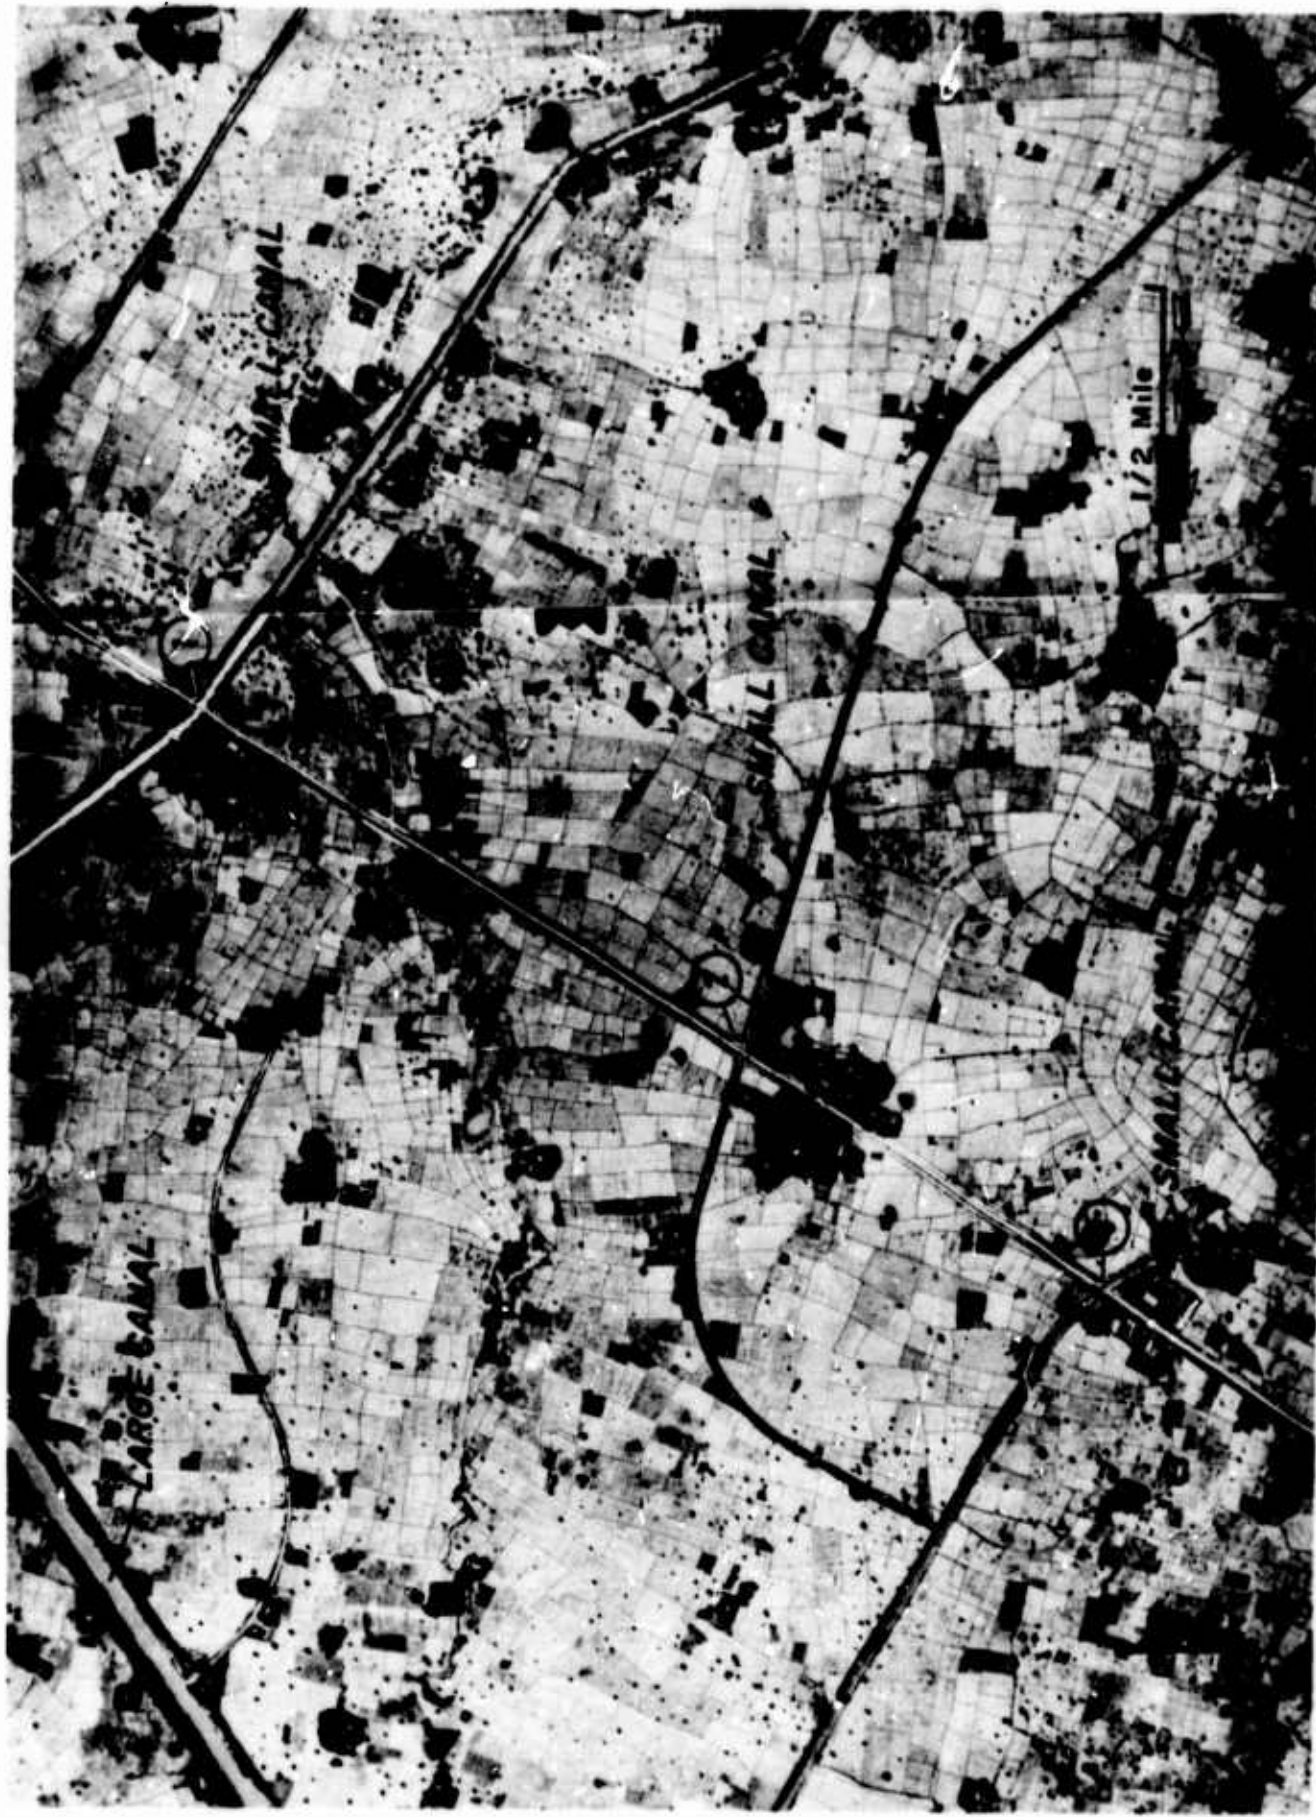
Fig. 209. Large canals--cross sections of large canals in the Lop Buri area
